<b>Tesla, Inc.</b> Service Bulletin		<b><i>Replace Refrigerant Pressure/Temperature Sensors</i></b>
<b>SB-21-18-001</b> February 5, 2021				
<b>Classification</b>		<b>Section/Group</b>		
Repair Bulletin		18 - Thermal Management		<b>Mobile Service</b>
				Cannot Perform
<b>Model Year</b>	<b>Model</b>	<b>Country/Region</b>		<b>Version</b>
2020 - 2021	Model 3, Model Y	All		Heat Pump
The model(s) and model year(s) listed are a general approximation of the affected VIN list. Refer to the VIN/Bulletin Tracker or Customer/Vehicle profile to determine applicability of this bulletin for a particular vehicle.

Some Model 3 and Model Y vehicles may be equipped with refrigerant pressure/temperature (P/T) sensors in the heat pump that can fault over time.

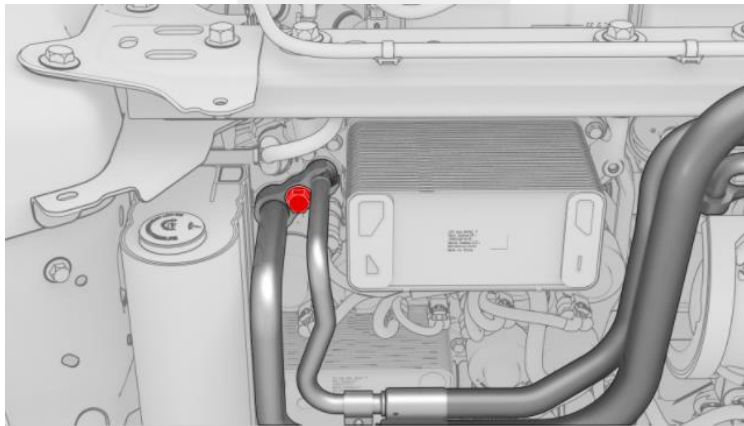
**Figure 1**

4. Remove the bolt that attaches the Supermanifold-to-compressor A/C line to the Supermanifold (Figure 1).

20. Connect the electrical harness to the low pressure P/T sensor connector, and then fasten the locking tab (Figure 3).
21. Release the Supermanifold-to-compressor A/C line from the S-hook (Figure 2), install the A/C line into the Supermanifold, hand-install the bolt that attaches the A/C line to the Supermanifold, and then tighten (torque 22 Nm) (Figure 1).

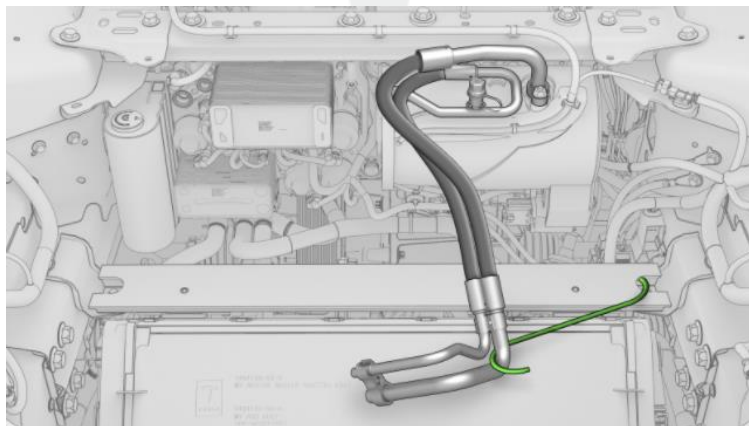
**Figure 2**

5. Remove the Supermanifold-to-compressor A/C line from the Supermanifold, and then use an S-hook to restrain the line to the underhood storage unit support beam (Figure 2).

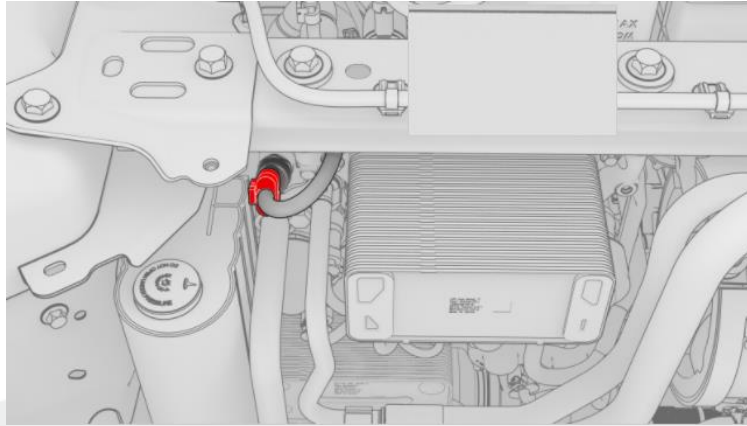
**Figure 3**

6. Release the locking tab, and then disconnect the electrical harness from the low pressure P/T sensor connector (Figure 3).

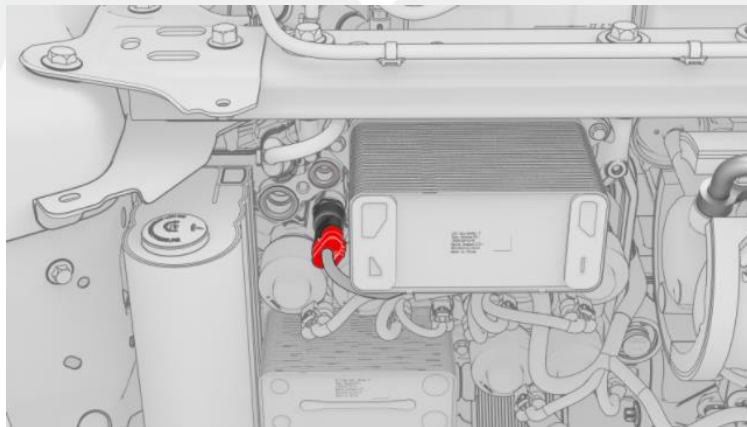
**Figure 4**

7. Release the locking tab, and then disconnect the electrical harness from the high pressure P/T sensor connector (Figure 4).

18. Connect the electrical harness to the subcool high pressure P/T sensor connector, and then fasten the locking tab (Figure 5).
19. Connect the electrical harness to the high pressure P/T sensor connector, and then fasten the locking tab (Figure 4).

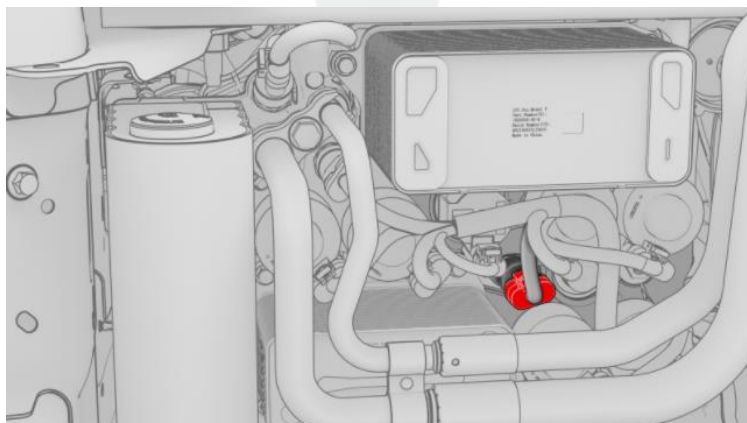
**Figure 5**

8. Release the locking tab, and then disconnect the electrical harness from the subcool high pressure P/T sensor connector (Figure 5).

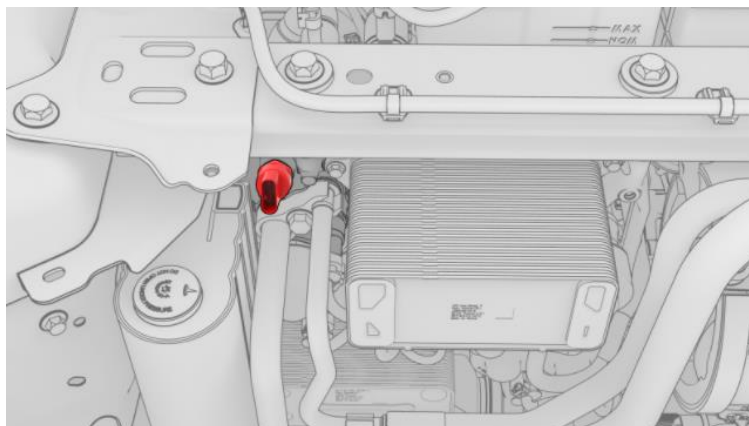
**Figure 6**

9. Use the HVAC socket kit to remove the low pressure P/T sensor from the Supermanifold (Figure 6).

17. Hand-install the new low pressure P/T sensor (brown connector) into the Supermanifold, and then use the HVAC socket kit to tighten (torque 9 Nm) (Figure 6).

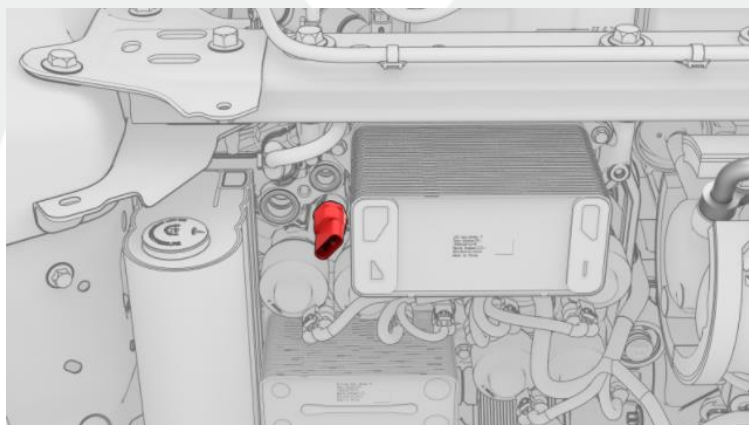
**Figure 7**

10. Use the HVAC socket kit to remove the high pressure P/T sensor from the Supermanifold (Figure 7).

16. Hand-install the new high pressure P/T sensor (black connector) into the Supermanifold, and then use the HVAC socket kit to tighten (torque 9 Nm) (Figure 7).

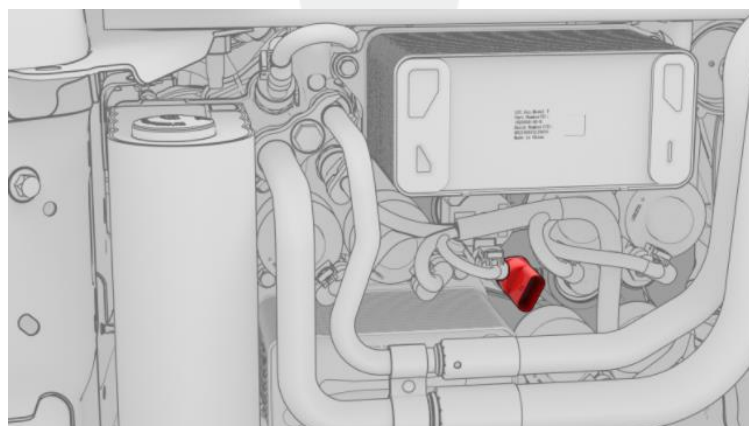
**Figure 8**

11. Use the HVAC socket kit to remove the subcool high pressure P/T sensor from the Supermanifold (Figure 8).

12. Return the removed P/T sensors to MRB as Special Interest, attention the HVAC Department.
13. If parts are available, install new washers on the Supermanifold-to-compressor A/C line.
14. Lubricate the washers of the Supermanifold-to-compressor A/C line and the O-rings and threads of the 3 new P/T sensors with ND-11 oil.
15. Hand-install the new subcool high pressure P/T sensor (black connector) into the Supermanifold, and then use the HVAC socket kit to tighten (torque 9 Nm) (Figure 8).
